Demonstration of Lead-Based Paint Removal From an Historic Wood Structure Using Laser Technology

Sponsored by: Environmental Management Division, Kelly Air Force

Performed by: U.S. Army Construction Engineering Research

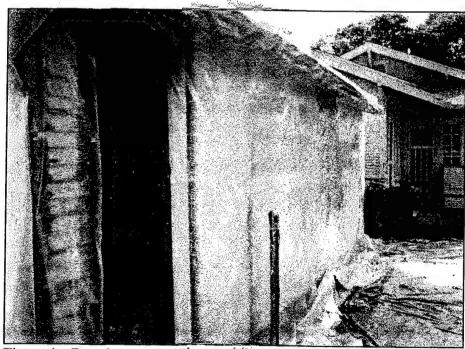
Figure 4. Containment for Chemical Stripping on Building 139

Before initiating chemical stripping on the exterior of the building, ground tarpaulins and six mil flame retardant polyethylene sheets were laid down to protect the soil from lead-based paint and/or chemical stripper contamination. Two layers of 20 by 100 foot six' mil flame-resistant polyethylene sheets were affixed to the foundation of the building a few feet up from the soil level so that they covered the foundation of the building and extended 15 feet out. Barrier tape and signs were posted in and around the site and on the exterior door. A portion of a fence surrounding the project site was removed in order for the required work to be performed. The containment is shown in Figure 4. The time required for construction of the containment system was approximately two hours for the laser system, and one working day for the chemical stripping.
